MICHIGAN DEPARTMENT OF TRANSPORTATION

STR 13 CULVERT SAFETY INSPECTION REPORT

Facility HURBERT ROAD	Latitude / Longitude 44.8591 / -83.5953	MDOT Structure ID 01200010000B010	Structure Condition Poor Condition(4)	
Feature THUNDER BAY RIVER	Length / Width / Spans 65 / 36.7 / 5	Owner County: Alcona(1)		
Location 1 MI N 6.5 MI W OF SPRUCE	Built / Recon. / Paint / Ovly. 1955 / / /	TSC Alpena(1)	Operational Status P Posted for load(162441)	
Region / County North(2) / Alcona(1)	Material / Design 3 Steel / 19 Culvert	Last NBI Inspection 05/13/2025 / 4ZDC	Scour Evaluation 5 Stable w/in footing

CULVERT INSPECTION 4ZDC

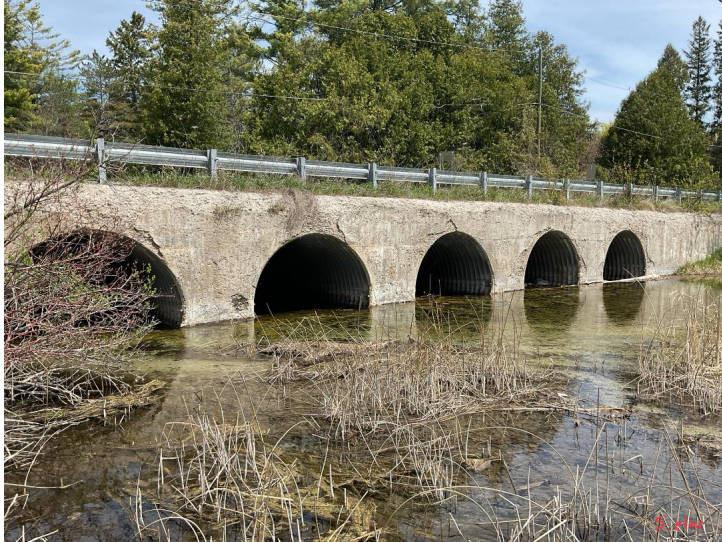
Document Name: IMG_0180.JPG
 Category: Elevation
 Span Number:
 Comments: South elevation

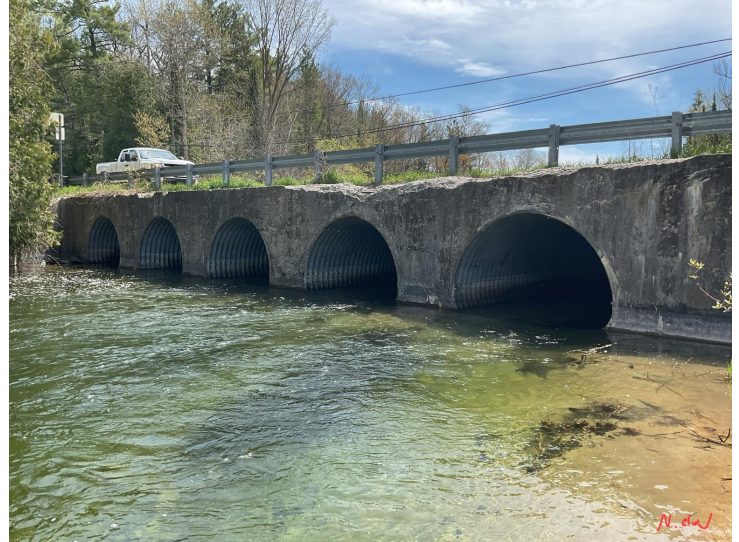
Document Name: IMG_0198.JPG
 Category: Elevation
 Span Number:
 Comments: North elevation

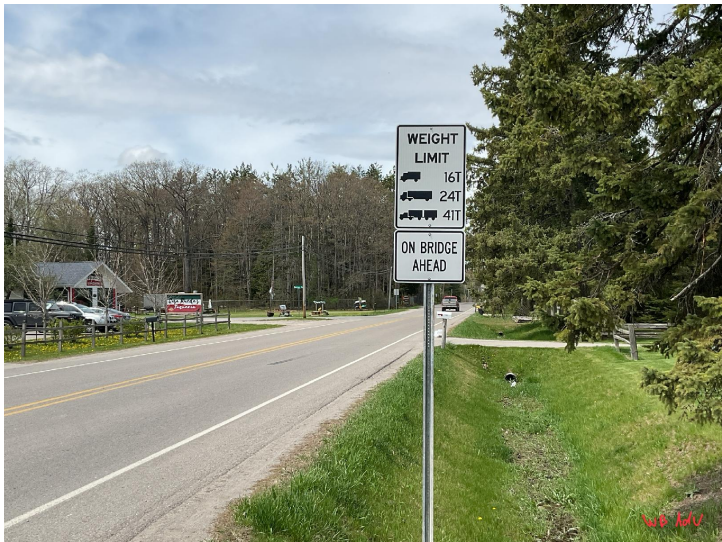
Document Name: IMG_0170.JPG
 Category: Posting
 Span Number:
 Comments: WB advanced load posting

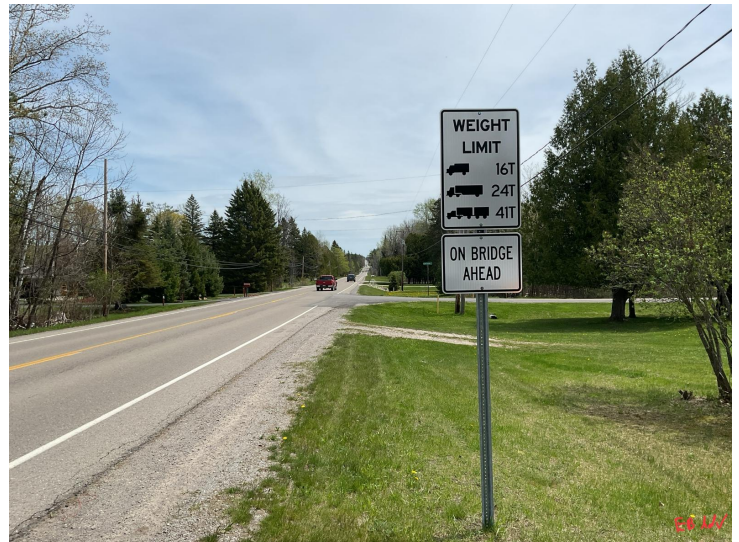
Document Name: IMG_0171.JPG
 Category: Posting
 Span Number:
 Comments: EB advanced load posting

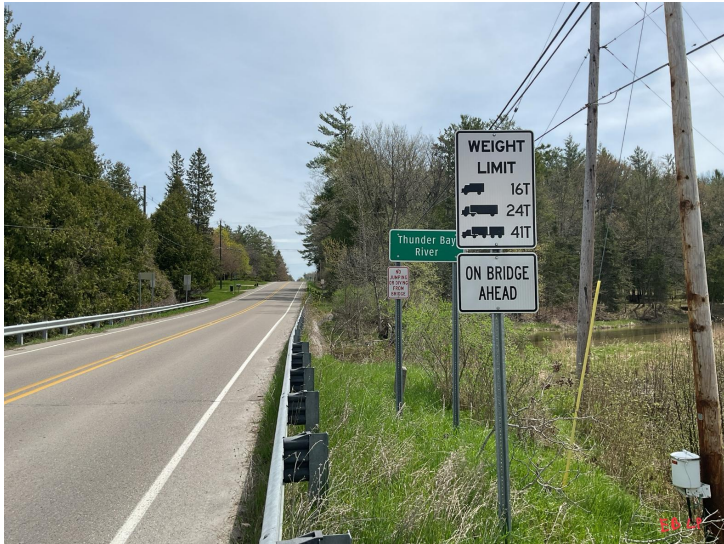
Document Name: IMG_0172.JPG
 Category: Posting
 Span Number:
 Comments: EB load posting

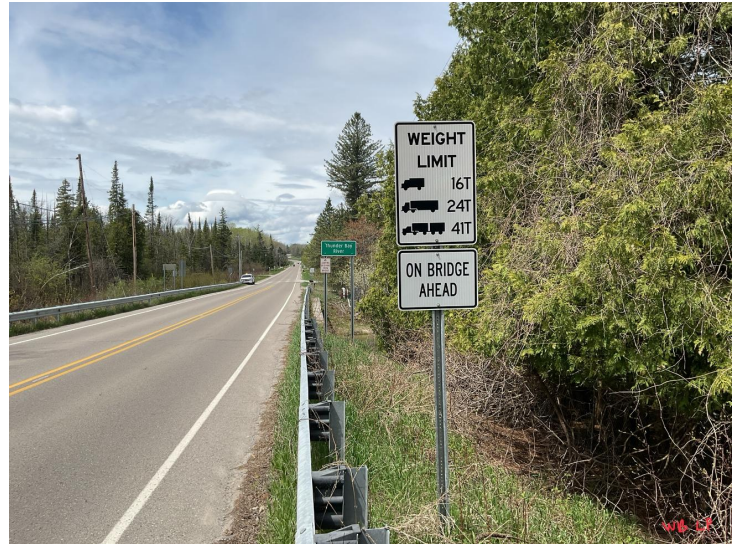
Document Name: IMG_0173.JPG
 Category: Posting
 Span Number:
 Comments: WB load posting

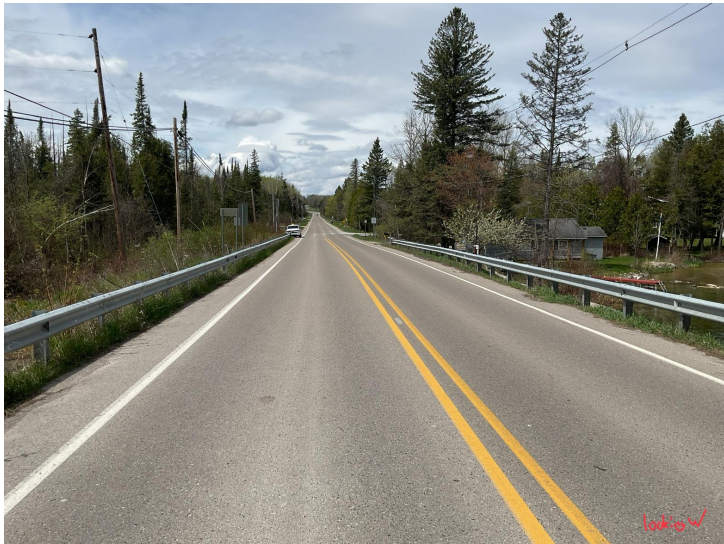
Document Name: IMG_0174.JPG
 Category: Approach
 Span Number:
 Comments: Looking west

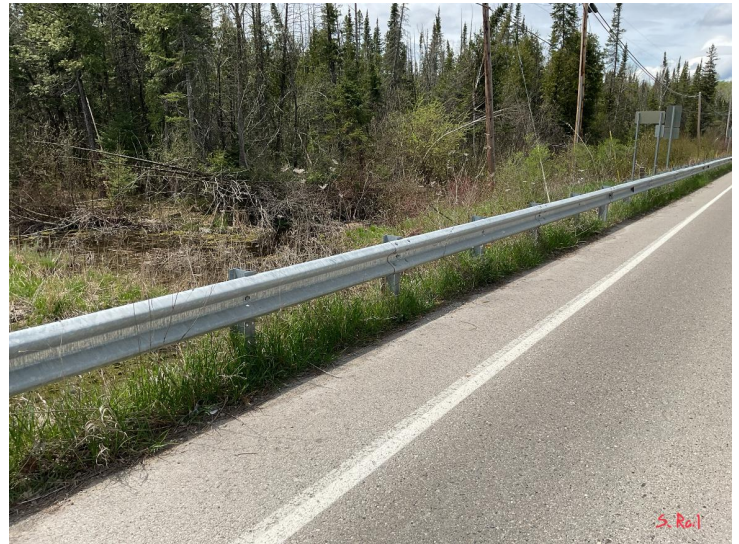
Document Name: IMG_0176.JPG
 Category: Railing
 Span Number:
 Comments: South rail

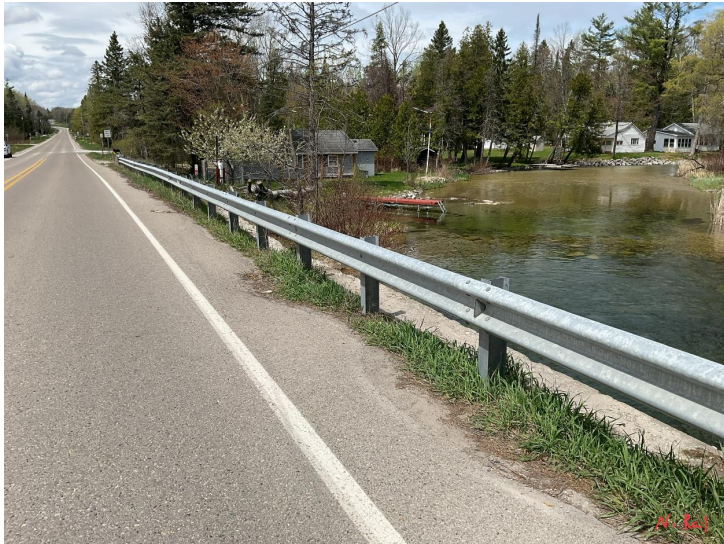
Document Name: IMG_0178.JPG
 Category: Railing
 Span Number:
 Comments: North rail

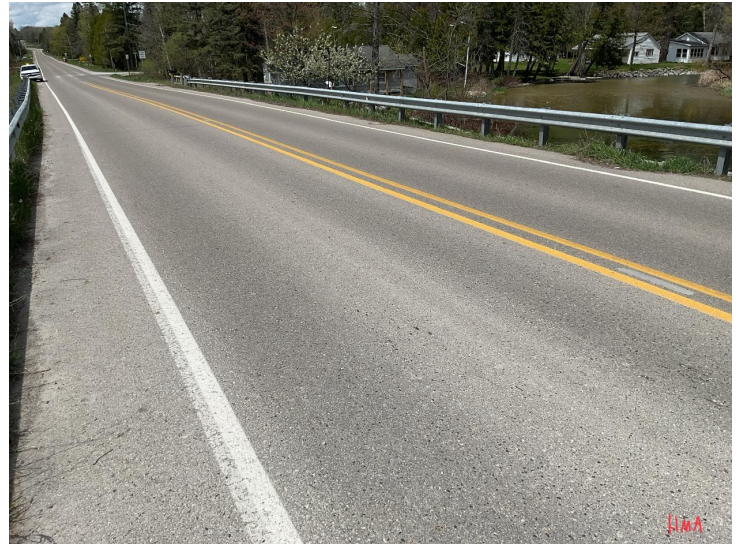
HMA over culvert has a few full width transverse cracks including at east reference line. Settlement in the north shoulder over barrels 2W and 3W.

Document Name: IMG_0175.JPG
 Category: Deck
 Span Number:
 Comments: HMA surface

Recommendation Type	Priority	Description
Seal Cracks	L	Seal cracks in surface as needed.
Header Repair	H	Patch spalls and delamination in headwalls.
Culvert Repl.	H	Schedule replacement.
Other	M	Fill in low spot/settlement along north shoulder.

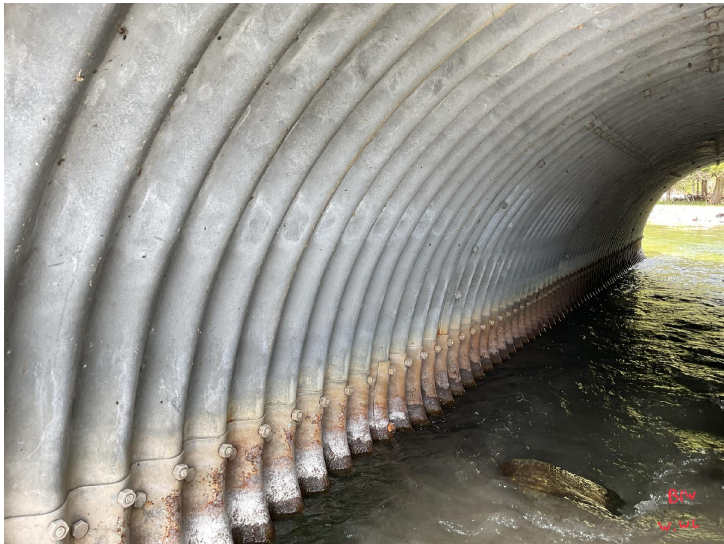
Document Name: IMG_0181.JPG
 Category: Culvert
 Span Number:
 Comments: Barrel 1W, west wall

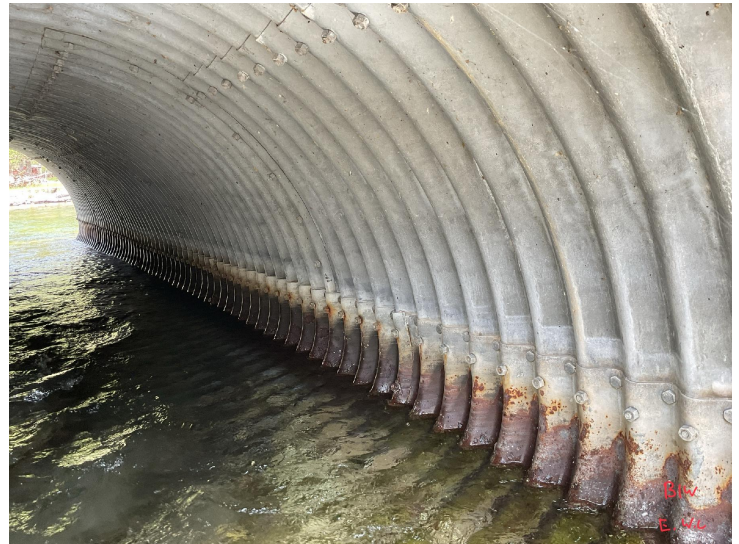
Document Name: IMG_0182.JPG
 Category: Culvert
 Span Number:
 Comments: Barrel 1W, east wall

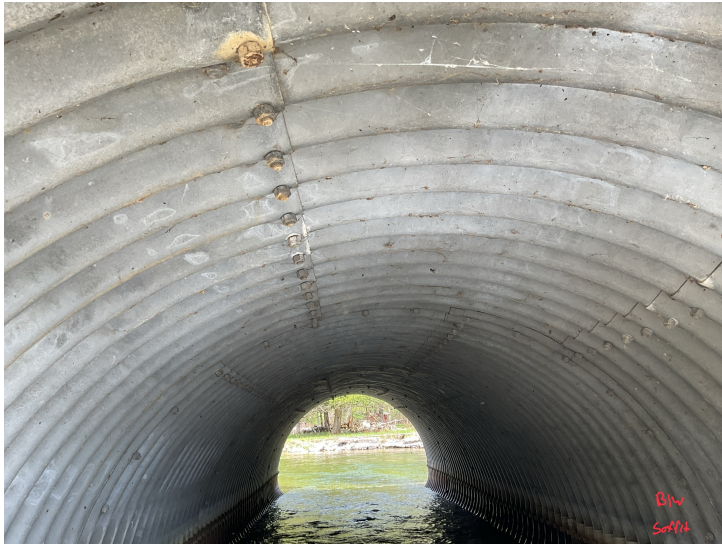
Document Name: IMG_0183.JPG
 Category: Culvert
 Span Number:
 Comments: Barrel 1W, soffit

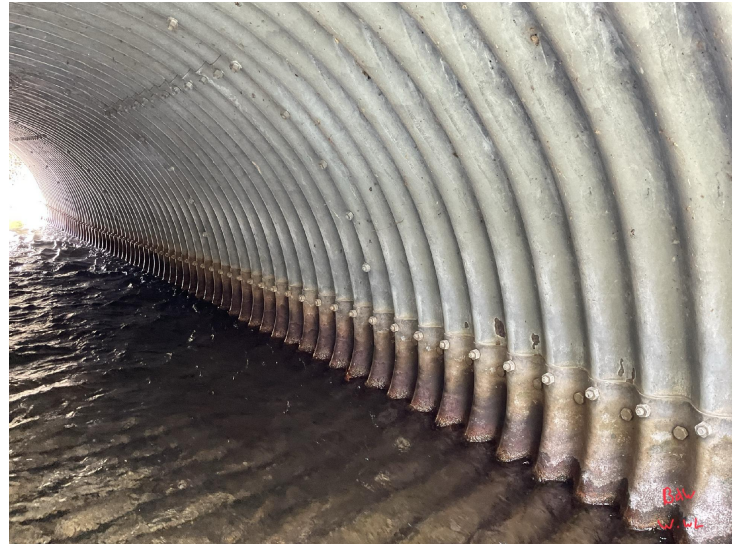
Document Name: IMG_0184.JPG
 Category: Culvert
 Span Number:
 Comments: Barrel 2W, west wall

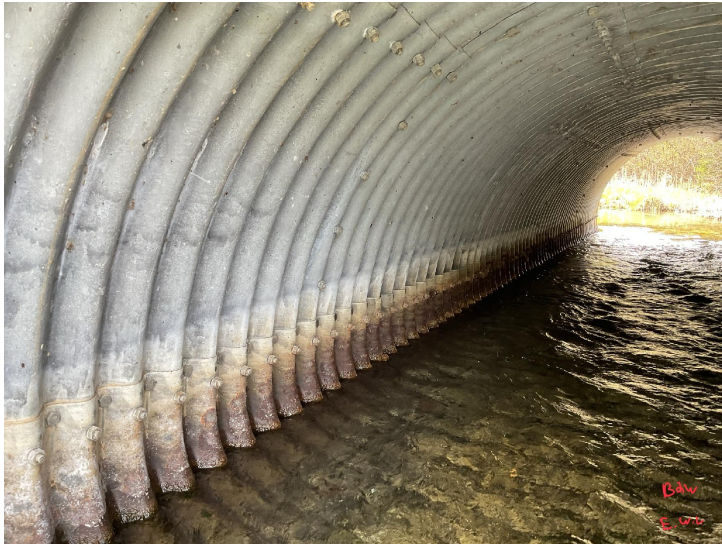
Document Name: IMG_0185.JPG
 Category: Culvert
 Span Number:
 Comments: barrel 2W, east wall

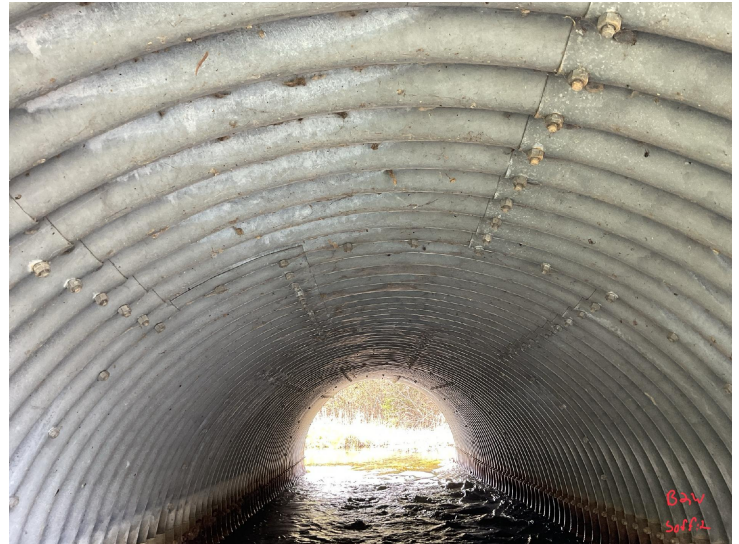
Document Name: IMG_0186.JPG
 Category: Culvert
 Span Number:
 Comments: Barrel 2W, soffit

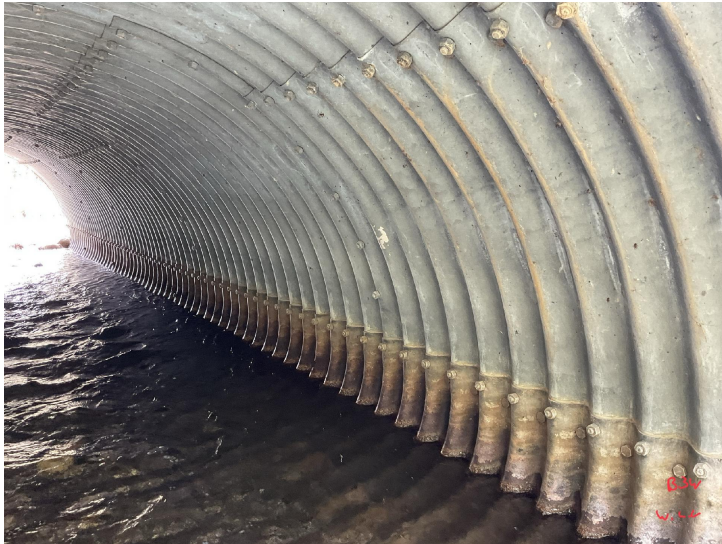
Document Name: IMG_0187.JPG
 Category: Culvert
 Span Number:
 Comments: Barrel 3W, west wall

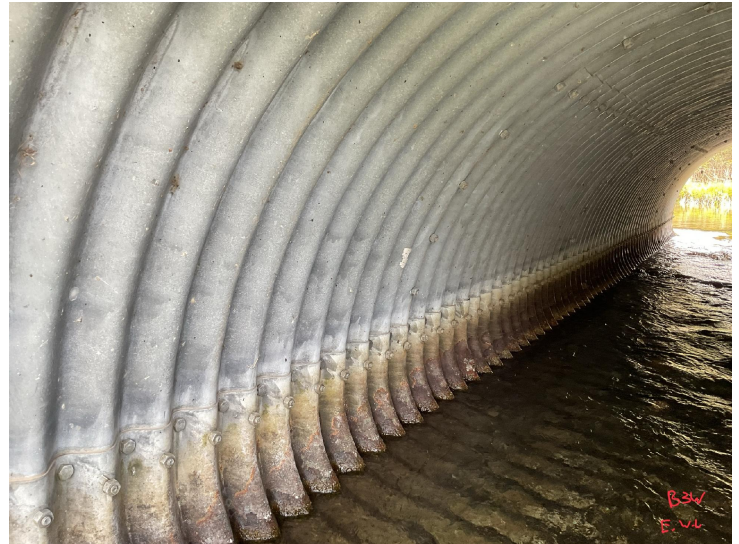
Document Name: IMG_0188.JPG
 Category: Culvert
 Span Number:
 Comments: Barrel 3W, east wall

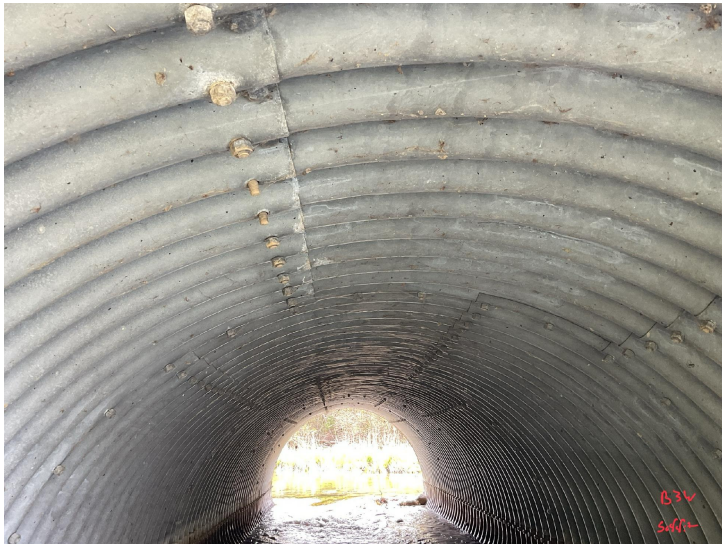
Document Name: IMG_0189.JPG
 Category: Culvert
 Span Number:
 Comments: Barrel 3W, soffit

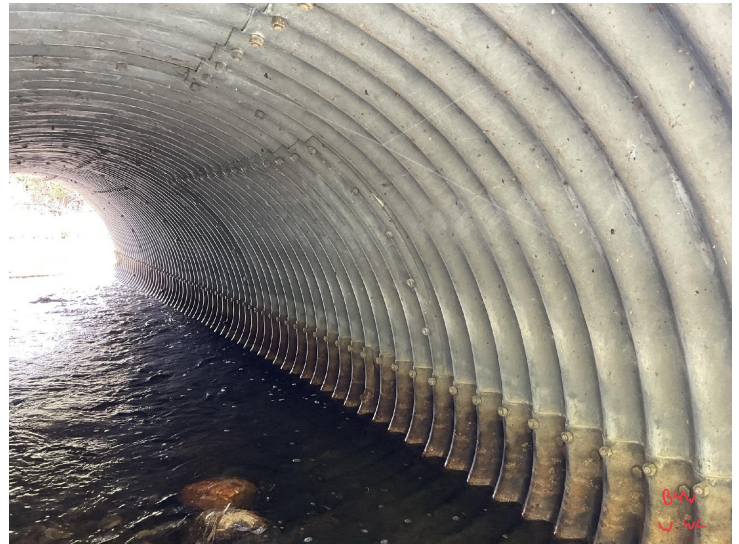
Document Name: IMG_0190.JPG
 Category: Culvert
 Span Number:
 Comments: barrel 4W, west wall

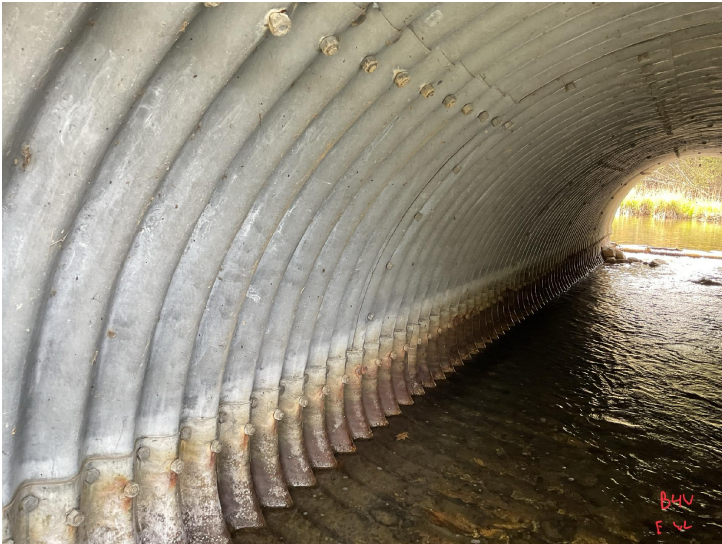
Document Name: IMG_0191.JPG
 Category: Culvert
 Span Number:
 Comments: Barrel 4W, east wall

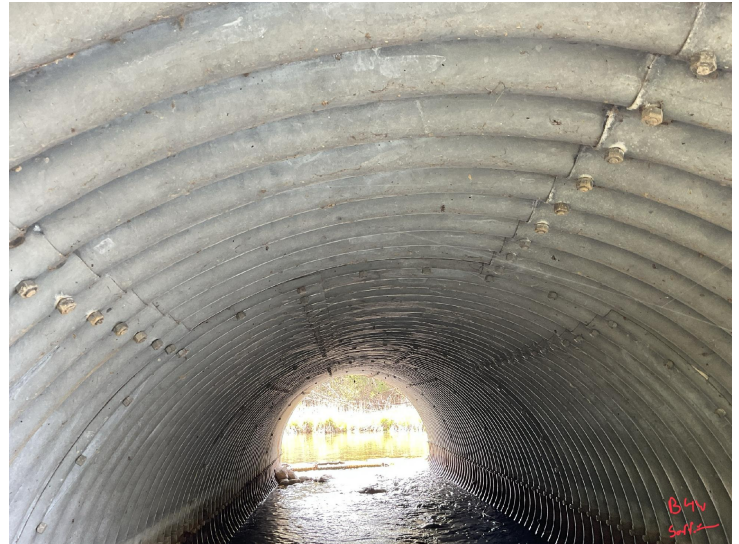
Document Name: IMG_0192.JPG
 Category: Culvert
 Span Number:
 Comments: Barrel 4W, soffit

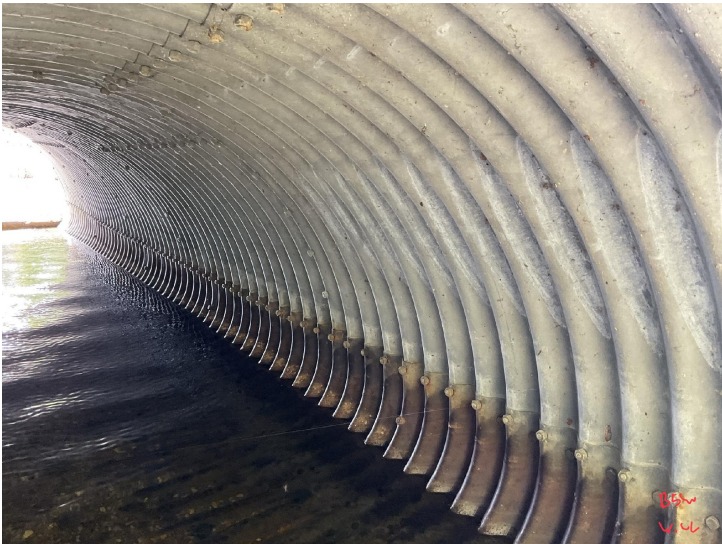
Document Name: IMG_0193.JPG
 Category: Culvert
 Span Number:
 Comments: Barrel 5W, west wall

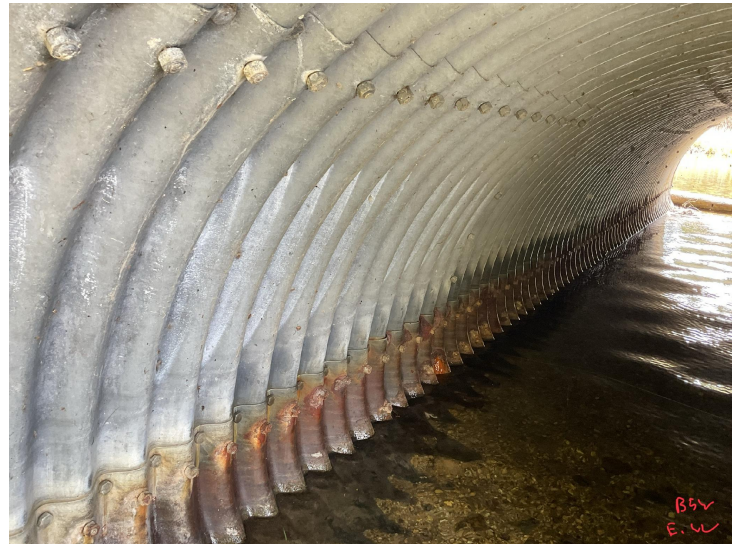
Document Name: IMG_0194.JPG
 Category: Culvert
 Span Number:
 Comments: Barrel 5W, east wall

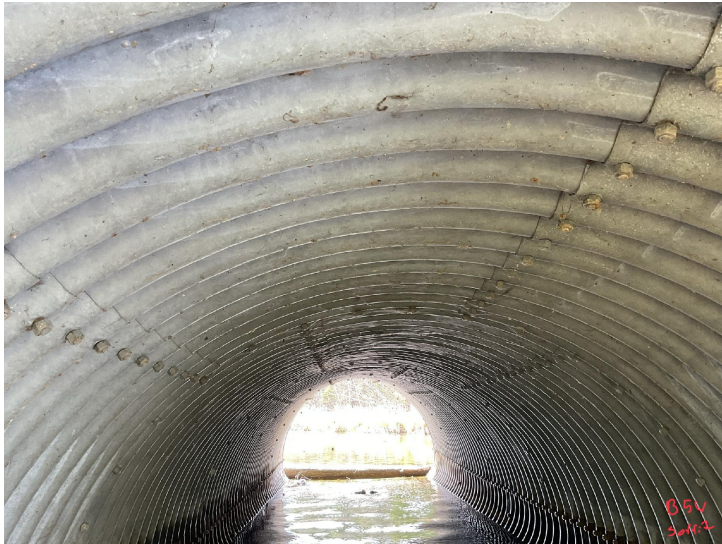
Document Name: IMG_0195.JPG
 Category: Culvert
 Span Number:
 Comments: Barrel 5W, soffit

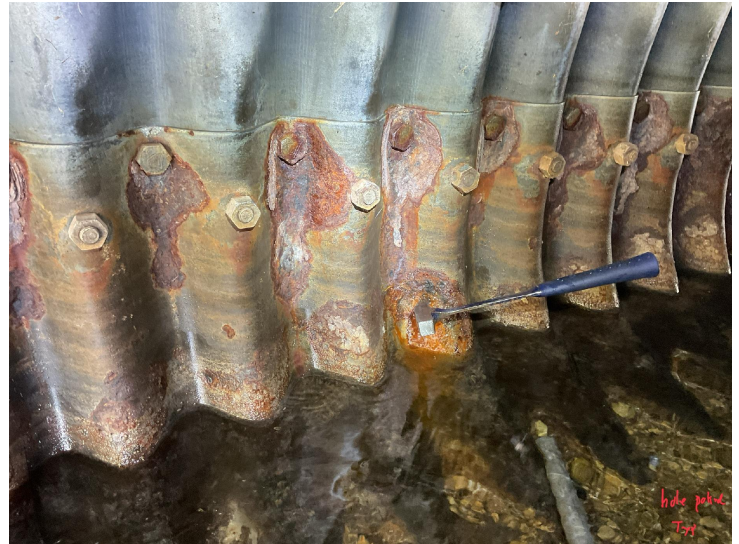
5-barrel CMP. Heavy rust and scale below the waterline of all five barrels. Settlement in north shoulder over barrels 2W and 3W.
 Barrel 1W: No holes along either waterline.
 Barrel 2W: Heavier scale along the east waterline with 6 existing hole.
 Barrel 3W: 3 holes along east waterline.
 Barrel 4W: Numerous holes along the full length of east wall.
 Barrel 5W: Numerous holes along the full length of east wall.

Document Name: IMG_0196.JPG
 Category: Culvert
 Span Number:
 Comments: Hole poked, typical

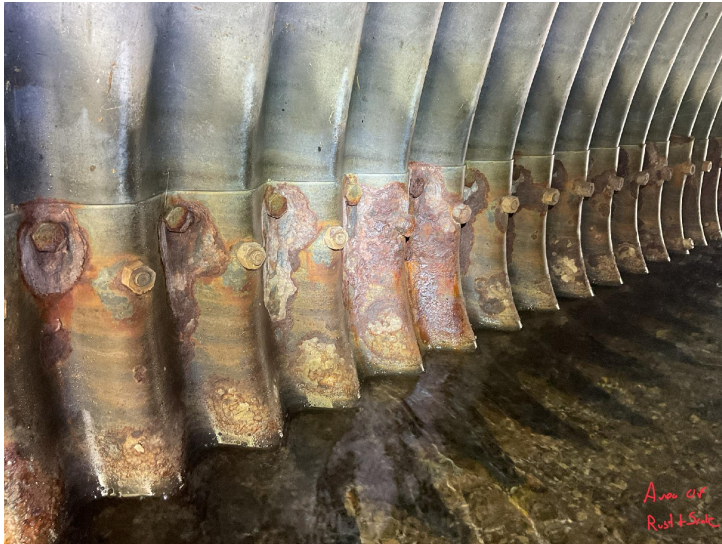
Document Name: IMG_0197.JPG
 Category: Culvert
 Span Number:
 Comments: Area of heavy rust and scale

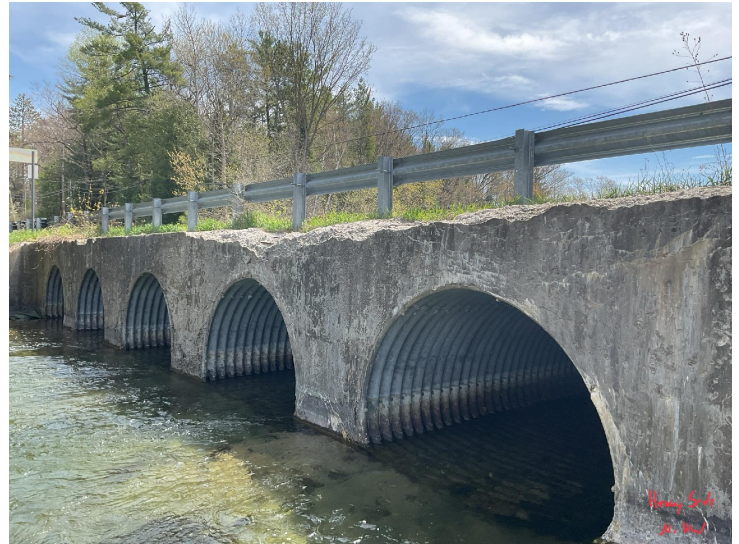
Concrete headwalls. Both have leaching horizontal cracks throughout and heavy spalling/scaling along the top and near the waterline.

Document Name: IMG_0199.JPG
 Category: Culvert
 Span Number:
 Comments: Heavy scale in north headwall

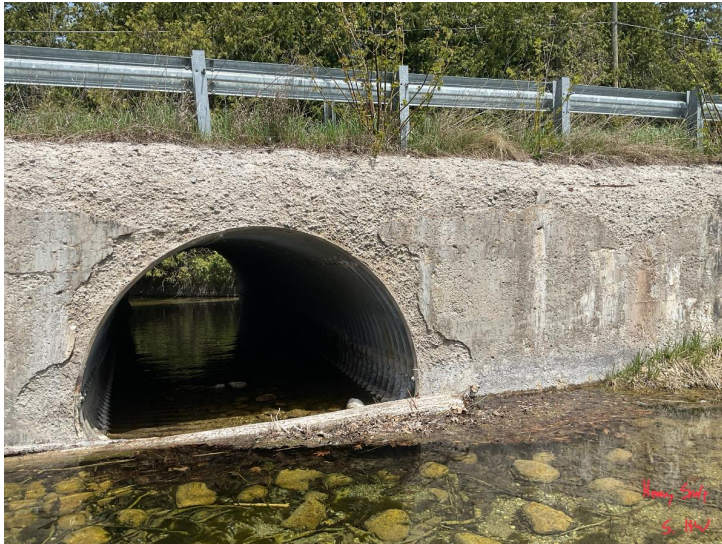
Document Name: IMG_0201.JPG
 Category: Culvert
 Span Number:
 Comments: Heavy scale in south headwall

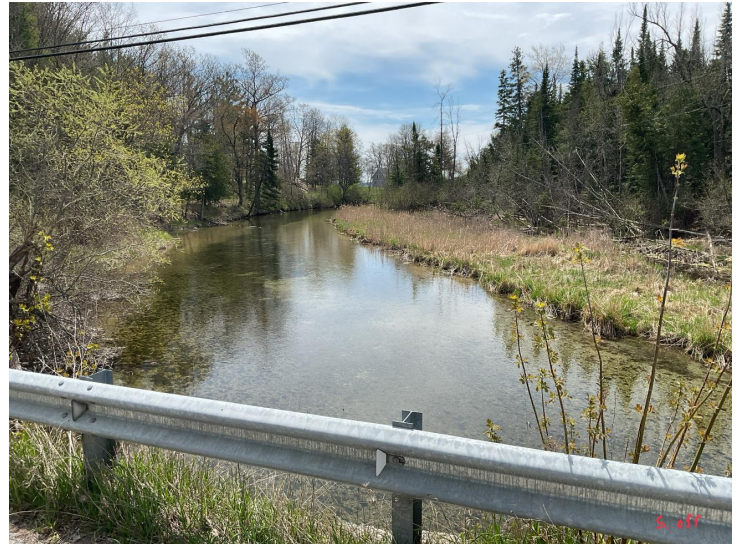
Document Name: IMG_0177.JPG
 Category: Channel
 Span Number:
 Comments: South channel

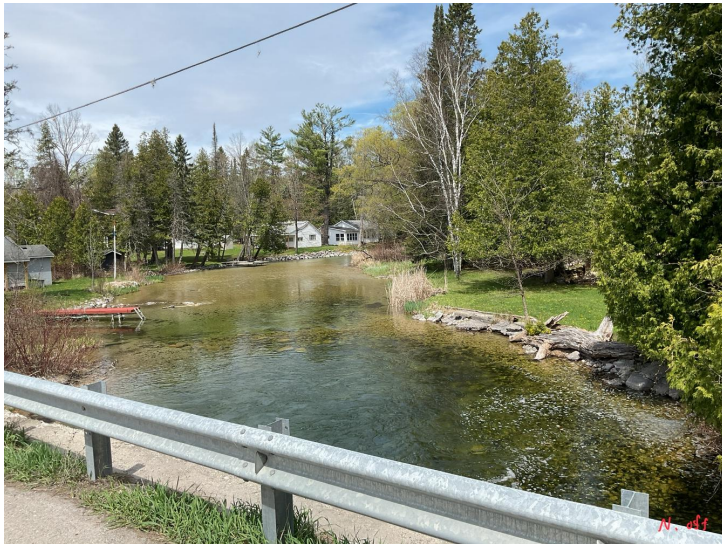
Document Name: IMG_0179.JPG
 Category: Channel
 Span Number:
 Comments: North channel

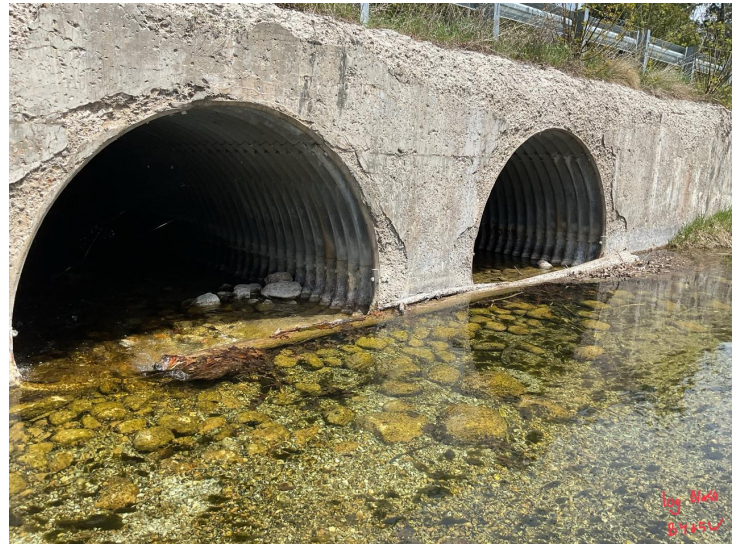
05/23	05/24	05/25	
1. Culvert Rating (SIA-62)	4	4	4	(05/25) (05/24) (05/23)
2. Channel (SIA-61)	5	5	5	Fast flow from south to north through barrels. Riprap in channel along upstream side. Channel deepens to 6'-8' deep 10' downstream of culvert. Timber debris stuck at the inlet of barrels 4W & 5W. Rocky and sandy channel bottom on both ends. (05/25) Fast flow from south to north through barrels. Riprap in channel along upstream side. Channel deepens to 6'-8' deep 10' downstream of culvert. Timber debris stuck at the inlet of barrel 3W removed. Rocky and sandy channel bottom on both ends. (05/24) Fast flow from south to north through barrels. Riprap in channel along upstream side. Channel deepens to 6'-8' deep 10' downstream of culvert. Timber debris stuck at the inlet of barrel 3W, debris is accelerating flow through barrels 1W-3W. Rocky and sandy channel bottom on both ends. Water is roughly 6"-12" higher than previous inspections. (05/23)

Document Name: IMG_0200.JPG
 Category: Channel
 Span Number:
 Comments: Timber debris blocking inlet of barrels 4W & 5W
