Structure Number 13 – Hubert Road over Thunder Bay River Bridge Replacement

The Alcona County Road Commission is requesting funding from the Local Bridge Program to replace the Hubert Road Bridge over Thunder Bay River, Structure Number 13. Full replacement of the bridge is proposed based on its condition and the undersized stream opening. The structure has a 2023 ADT of 2375.

STR 13 CULVERT SAFETY INSPECTION REPORT

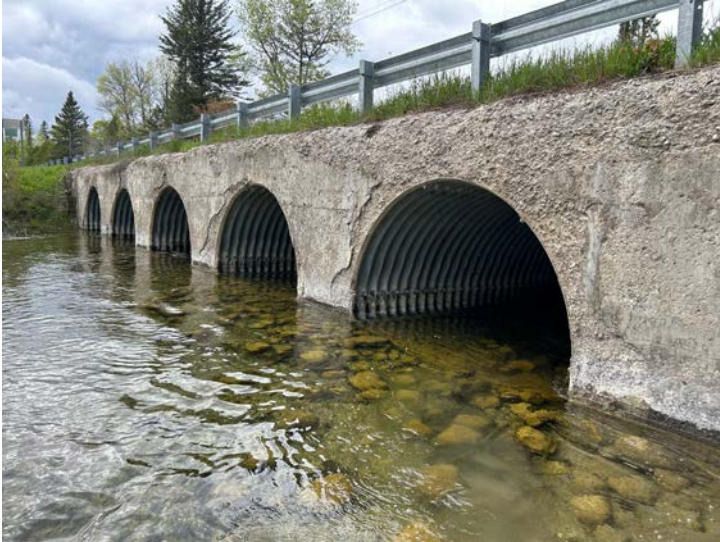
Document Name: IMG_5681 conv.jpeg
 Category: Elevation
 Span Number:
 Comments: S elevation

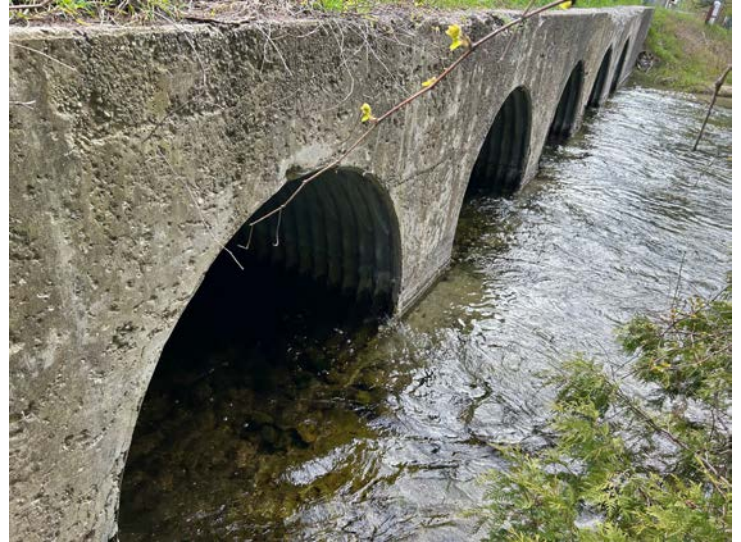
Document Name: IMG_5682 conv.jpeg
 Category: Elevation
 Span Number:
 Comments: N elevation

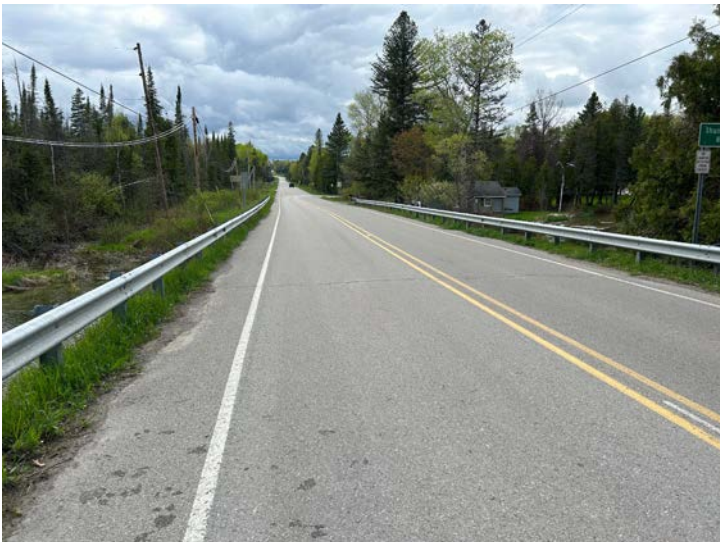
Document Name: IMG_5683 conv.jpeg
 Category: Elevation
 Span Number:
 Comments: Looking through from E approach

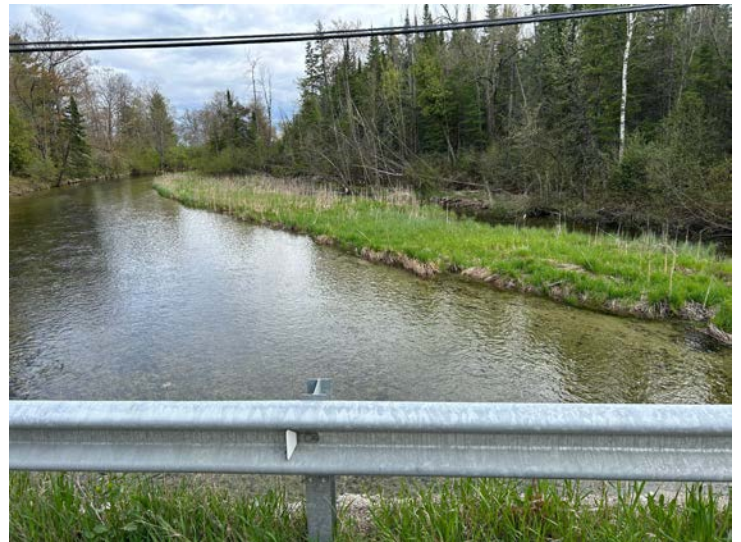
Document Name: IMG_5686 conv.jpeg
 Category: Elevation
 Span Number:
 Comments: Looking S off structure

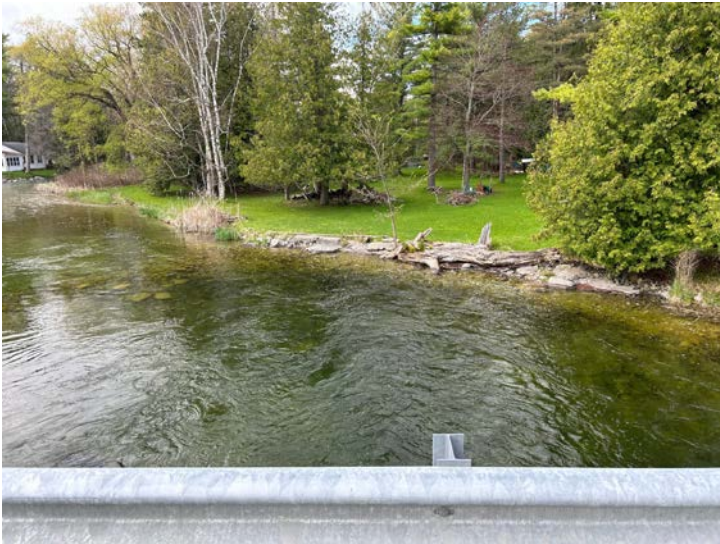
Document Name: IMG_5687 conv.jpeg
 Category: Elevation
 Span Number:
 Comments: Looking N off structure

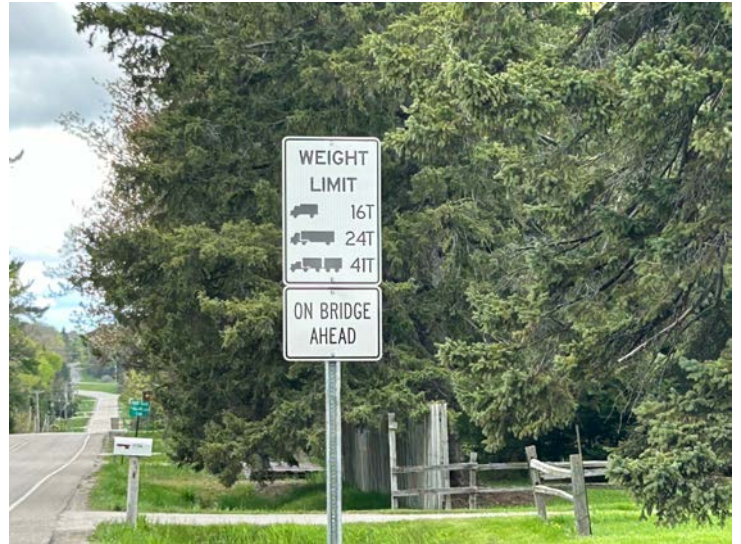
Document Name: IMG_5665 conv.jpeg
 Category: Posting
 Span Number:
 Comments: E advanced posting

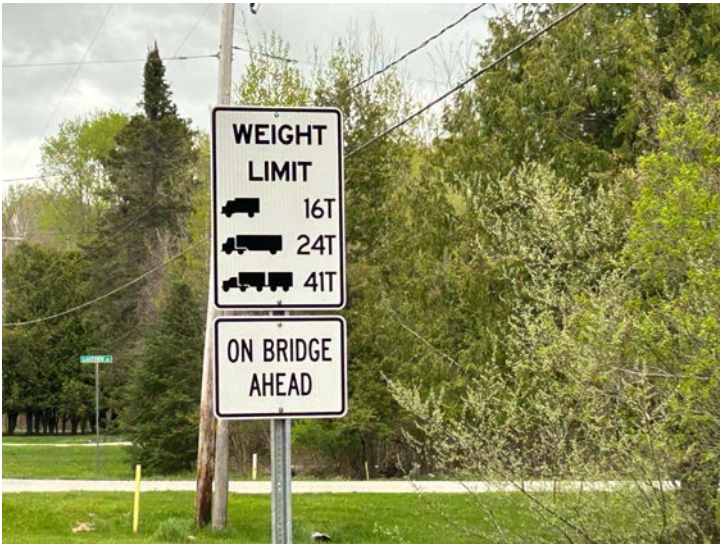
Document Name: IMG_5666 conv.jpeg
 Category: Posting
 Span Number:
 Comments: W advanced posting

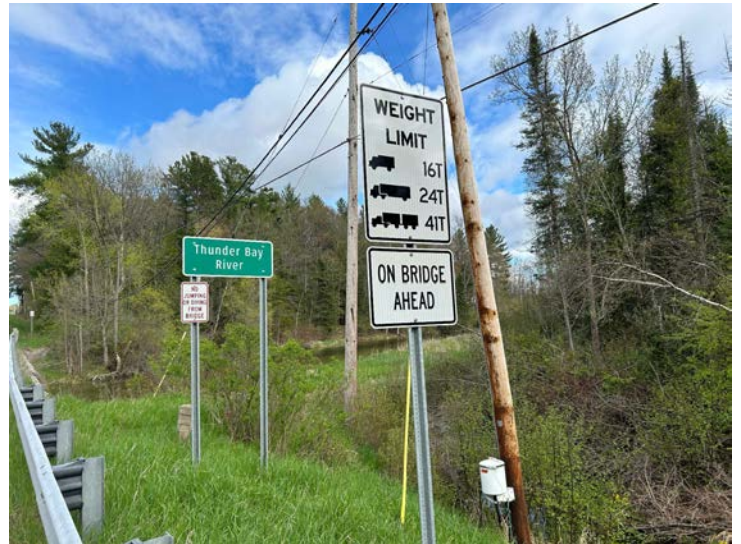
Document Name: IMG_5689 conv.jpeg
 Category: Posting
 Span Number:
 Comments: W posting

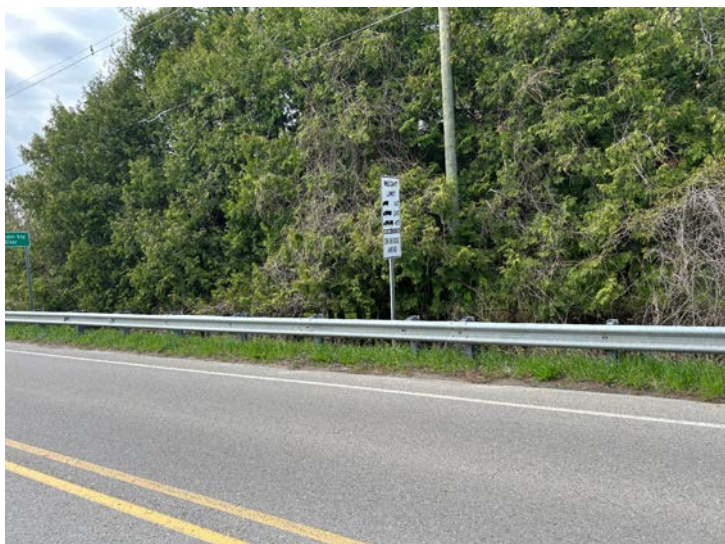
Document Name: IMG_5690 conv.jpeg
 Category: Posting
 Span Number:
 Comments: E posting

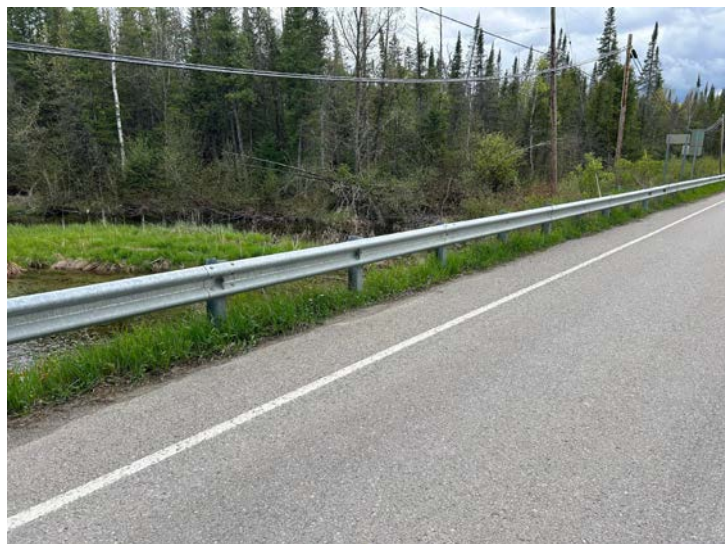
Document Name: IMG_5684 conv.jpeg
 Category: Railing
 Span Number:
 Comments: S rail

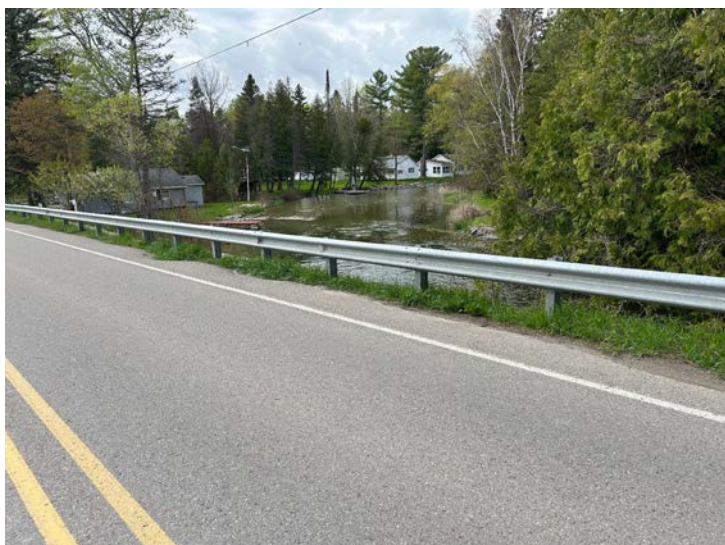
Document Name: IMG_5685 conv.jpeg
 Category: Railing
 Span Number:
 Comments: N rail

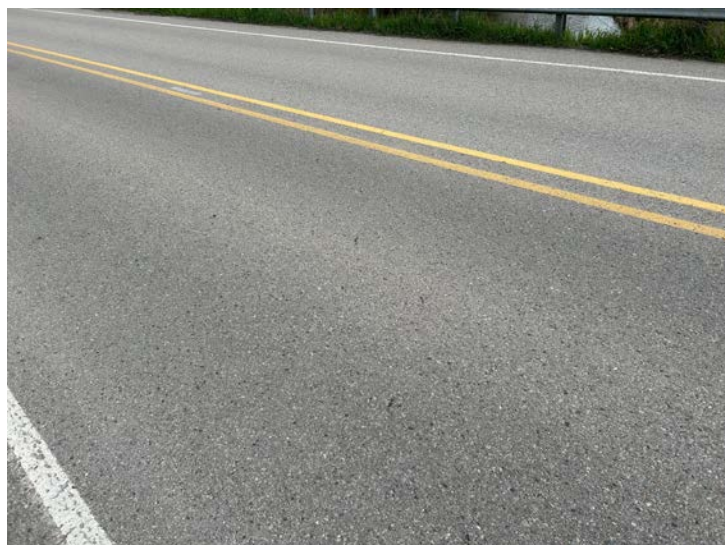
HMA over culvert has a few full width transverse cracks including at east reference line. Settlement in the north shoulder over barrels 2W and 3W.

Document Name: IMG_5688 conv.jpeg
 Category: Deck
 Span Number:
 Comments: Deck surface - typ.

DECKSLABS				
Request For	Contact/User	Agency/Company Name	Estimated Quantity	Unit
Seal Cracks				
Activity	Material	Other Material	Actual Quantity	Unit
Personnel Hours	Equipment			Complete Date
Comments				
Seal cracks in surface as needed. (Eric Rickert 05/16/2024)

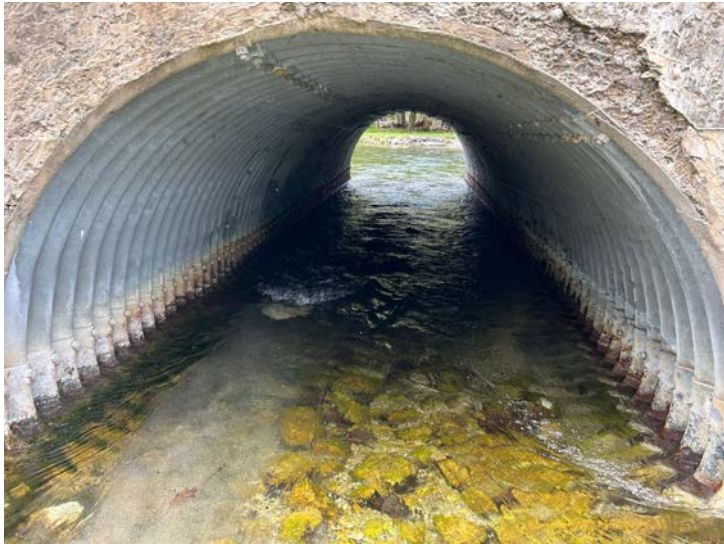
Document Name: IMG_5667 conv.jpeg
 Category: Culvert
 Span Number:
 Comments: Barrel 1W from S

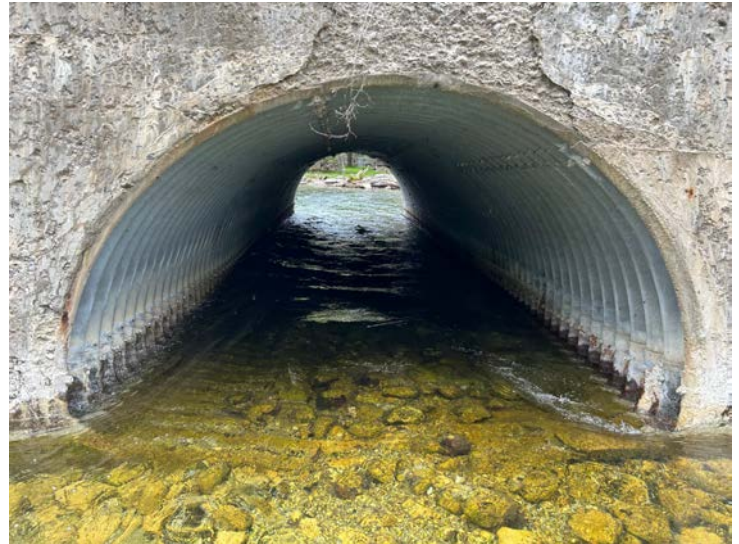
Document Name: IMG_5668 conv.jpeg
 Category: Culvert
 Span Number:
 Comments: Barrel 2W from S

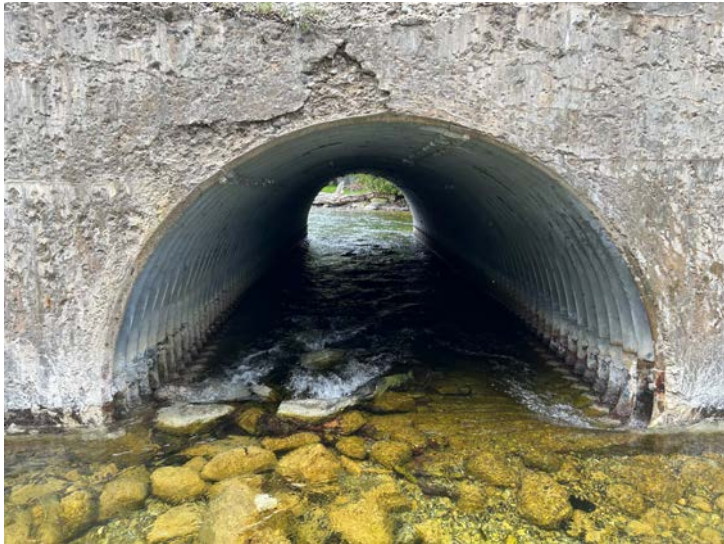
Document Name: IMG_5669 conv.jpeg
 Category: Culvert
 Span Number:
 Comments: Barrel 3W from S

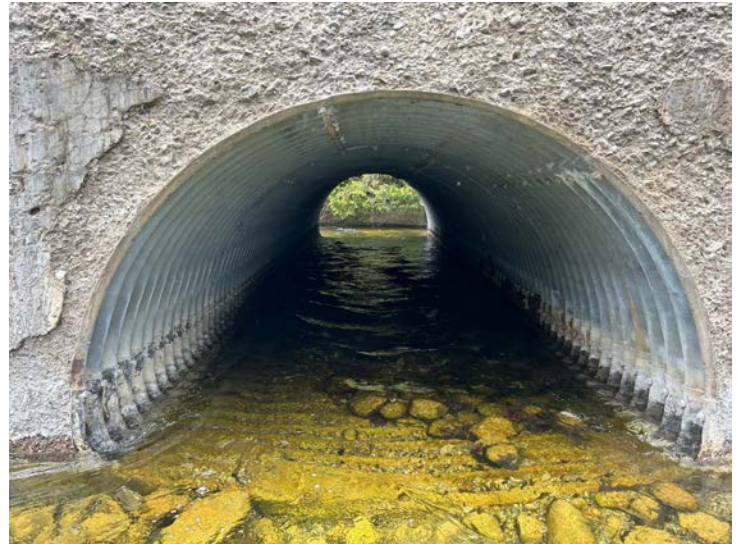
Document Name: IMG_5671 conv.jpeg
 Category: Culvert
 Span Number:
 Comments: Barrel 5W from S

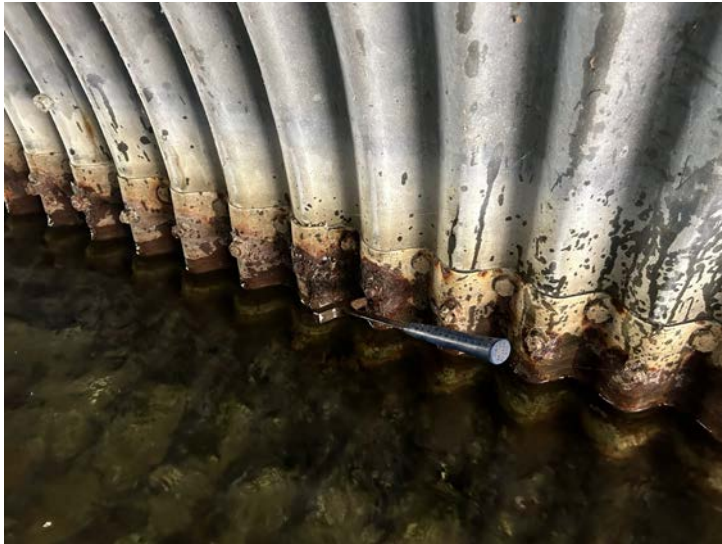
Document Name: IMG_5672 conv.jpeg
 Category: Culvert
 Span Number:
 Comments: Barrel 2W, E wall, hammer in hole - typ.

5-barrel CMP. Heavy rust and scale below the waterline of all five barrels. Inspector was able to poke one (1) new hole in the east wall of barrel 2W and 5W. Previous comments: Barrel 1W, no holes along the waterline. Barrel 2W, heavier scale along the east waterline with 5 holes. Barrel 3W, three holes along the east waterline. Barrels 4W and 5W, numerous holes along the east waterline of both barrels. Settlement in north shoulder over barrels 2W and 3W.

OTHER				
Request For	Contact/User	Agency/Company Name	Estimated Quantity	Unit
Culvert Repl.				
Activity	Material	Other Material	Actual Quantity	Unit
Personnel Hours	Equipment			Complete Date
Comments				
Schedule replacement. (Eric Rickert 05/16/2024)

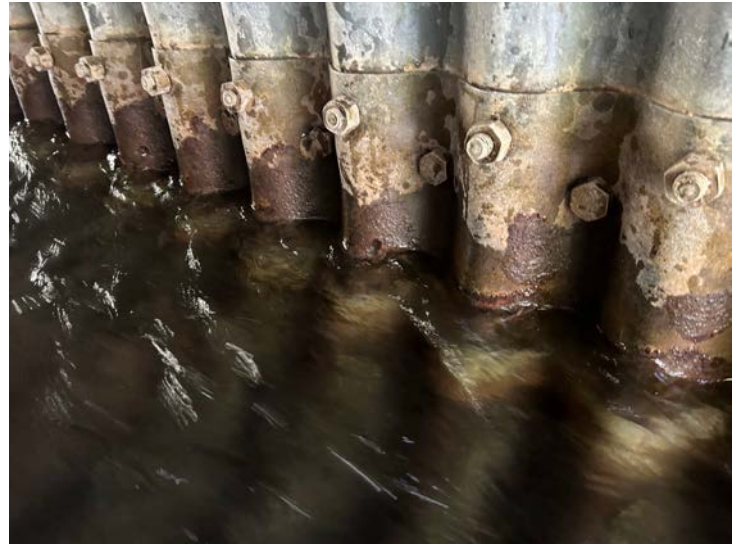
Document Name: IMG_5673 conv.jpeg
 Category: Culvert
 Span Number:
 Comments: Barrel 2W, E wall, existing holes - typ.

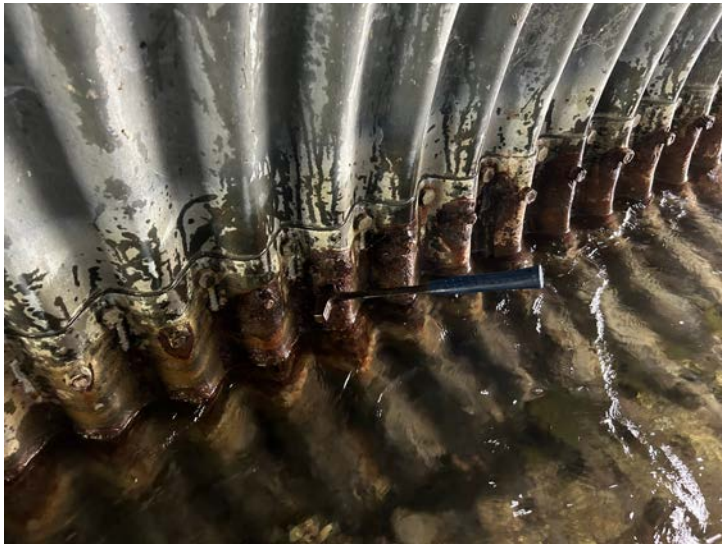
Document Name: IMG_5674 conv.jpeg
 Category: Culvert
 Span Number:
 Comments: Barrel 4W, E wall, hammer in hole - typ.

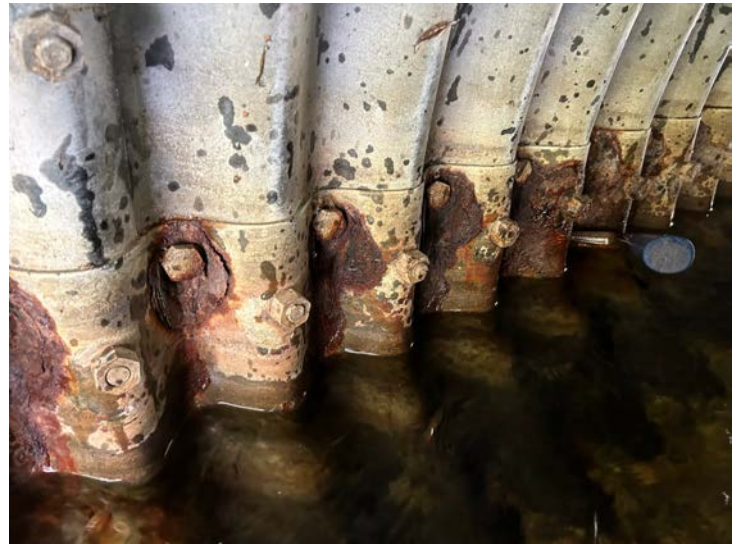
Document Name: IMG_5676 conv.jpeg
 Category: Culvert
 Span Number:
 Comments: Barrel 5W, W wall, scale at WL

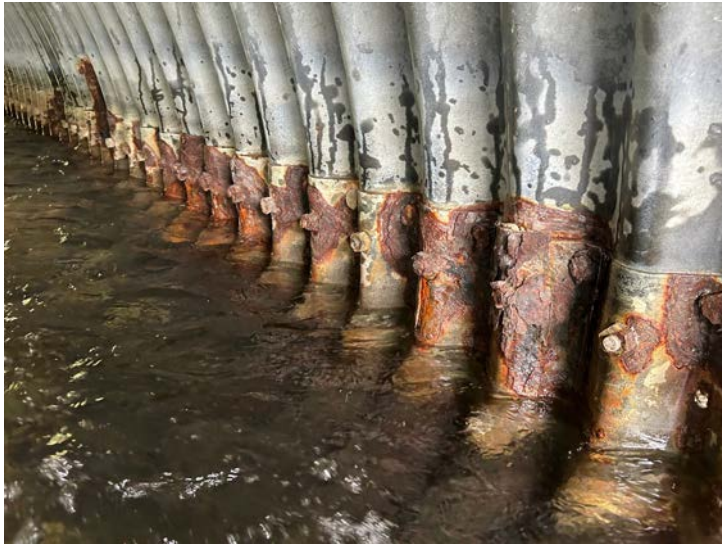
Document Name: IMG_5680 conv.jpeg
 Category: Culvert
 Span Number:
 Comments: Barrel 5W, E wall, scale at WL

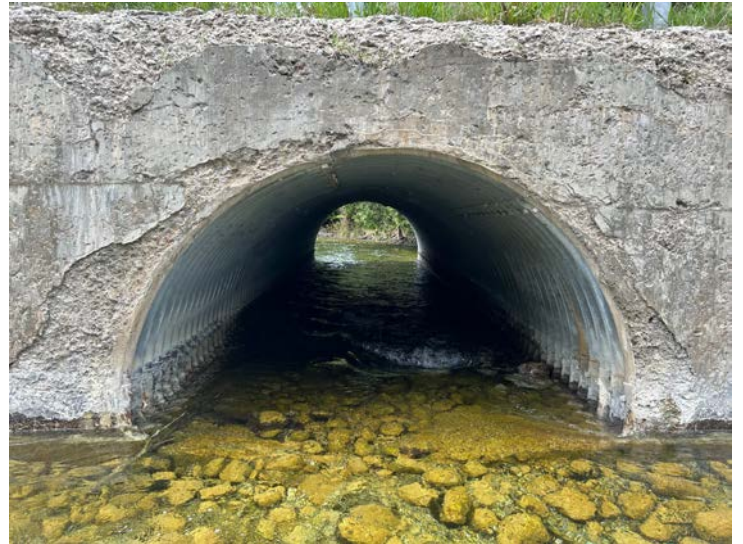
Document Name: IMG_5670 conv.jpeg
 Category: Channel
 Span Number:
 Comments: Barrel 4W from S
