Structure Number 13 – Hubert Road over Thunder Bay River Bridge Replacement

The Alcona County Road Commission is requesting funding from the Local Bridge Program to replace the Hubert Road Bridge over Thunder Bay River, Structure Number 13. Full replacement of the bridge is proposed based on its condition and the undersized stream opening. The structure has a 2023 ADT of 2375.

STR 13 CULVERT SAFETY INSPECTION REPORT

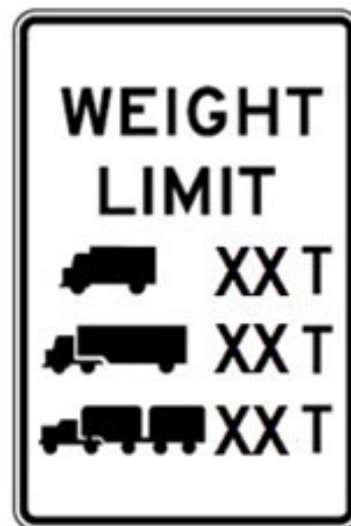
R12-5

NBI Item 63 - Operating Rating Method 6 LFR in Rating Factor
NBI Item 64F - Federal Operating Ratings 0.53
MDOT Item 64MA - Michigan Operating Method 6 LFR in Rating Factor
MDOT Item 64MB - Michigan Operating Rating 0.94
MDOT Item 64MC - Michigan Operating Truck 6
NBI Item 65 - Inventory Rating Method 6 LFR in Rating Factor
NBI Item 66 - Federal Inventory Rating 0.32
NBI Item 41 - Structure Open Posted Closed P P Posted for load
NBI Item 70 - Bridge Posting 0 0 - 59% or less
Posted By Truck Type
MDOT Item 141 - Posted Loading 162441
MDOT Item 193A - Michigan Overload Class
MDOT Item 193C - Overload Status
